SSC Service Bulletin

no. 80-189

MODELS AFFECTED: MICRO COM BU SERIES

PROBLEM: NO TRANSMITTER DISABLE WITH MA-130 INSTALLED

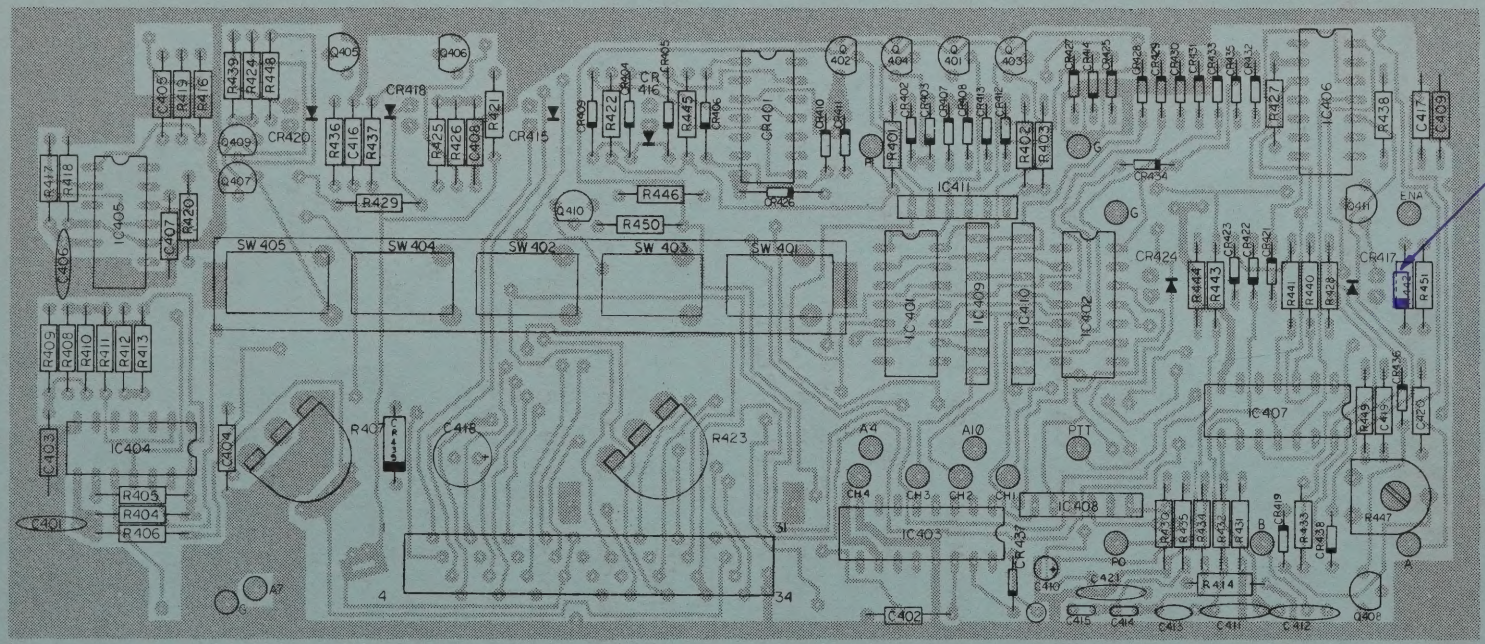
REPLACE R442
WITH CR440
SW 405
SW 404
SW 402
SW 403
SW 401
IC401
IC402
IC403
IC404
IC405
IC406
IC407
IC408
IC409
IC410
IC411
R407
R423
C418
CR418
CR420
CR415
CR416
CR417
CR424
CR434
R429
R446
R450
Q410
Q409
Q407
Q405
Q406
Q401
Q402
Q403
Q404
Q411
Q408
A4
A10
PTT
CH4
CH3
CH2
CH1
A7
G
P0
P3
A
4
34
31

CURE: REPLACE R442 WITH DIODE (CATHODE TOWARDS THE BASE OF Q408), CR440, P/N 4805-1241-200 (SEE FIGURE 1)

The schematic in the Service Manual should be brought up to a Rev. F. CR440 should be put in place of R442 on the schematic and last used block CR439 changed to CR440.
